CONTAMINANTS EFFECTS ON ROTATING ELECTRICAL MACHINES WINDINGS

WALTER EVALDO KUCHENBECKER¹, DANIEL RODRIGO MORETTI²

KEY WORDS: dielectrics, contaminants, aging, leakage path (tracking).

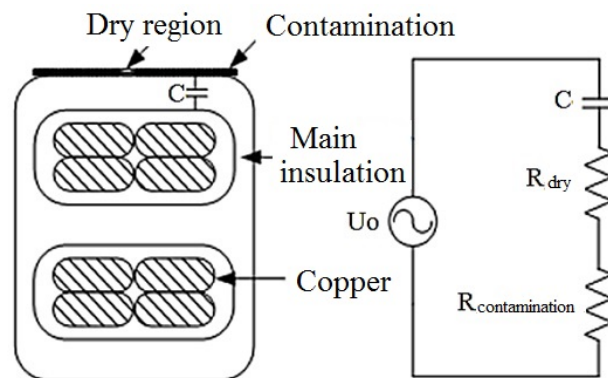
The Figure 2 presents the model of a contaminated insulation. As a result of contamination, regions that are called “dry” are usually created and shown as R_{dry} and other $R_{contamination}$. The drier regions are characterized by having a much greater resistance than the other contaminated regions and in this situation, any potential difference (phase-to-phase voltage) is established on this higher resistance small region.

The high potential difference, in this small contaminated region, dry and isolated, causes the rupture of the dielectric strength of the atmospheric air around it. These electrical discharges degrade and carbonize the organic resin and the insulation system tapes in the dry region, making it more conductive. The increase in conductivity in this small area makes it possible to establish the phase-to-phase potential difference in another small region and, therefore, carbonization becomes a successive process.

Figure 2: Coil head cross section of a high voltage stator and its respective equivalent circuit that shows the leakage current flow (Source: LIN, L; 2016)

The levels of partial discharges represent a downward trend in magnitudes when comparing the test before and after contamination. This behavior may be related to the high humidity applied to the sawdust during the contamination simulation. The high humidity causes an increase in the leakage current between the windings of different phases "equalizing" the potential difference over the contaminating material. The effect of the leakage path (tracking) is caused when the contaminated region presents a high potential difference and this occurs only in contaminated and dry regions, according to the model in figure 2.

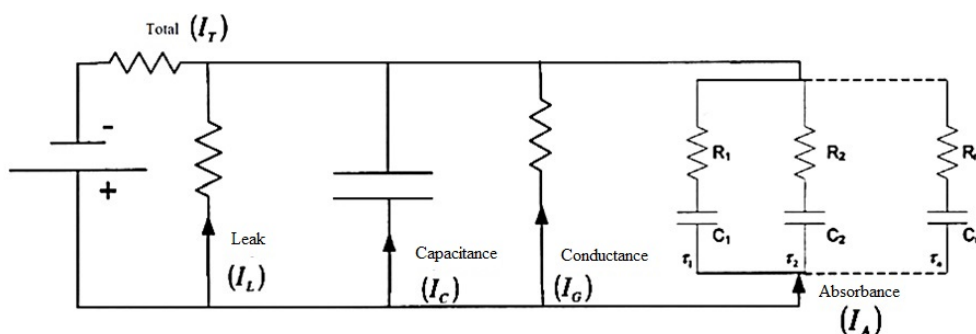
The diagnosis of the insulation system performed according to IEEE43 is definitely the most widespread and provides a quick and accessible response. The imposition of DC voltage and leakage current measurement makes it possible to determine important characteristics such as the insulation resistance value for 1 minute and the polarization index (PI). Although the test run is relatively simple, the figure 3 shows the equivalent insulation circuit for an insulation resistance and polarization index test.

Figure 3: Insulation monitoring equivalent circuit during the insulation resistance test (Source: IEEE43; 2013)

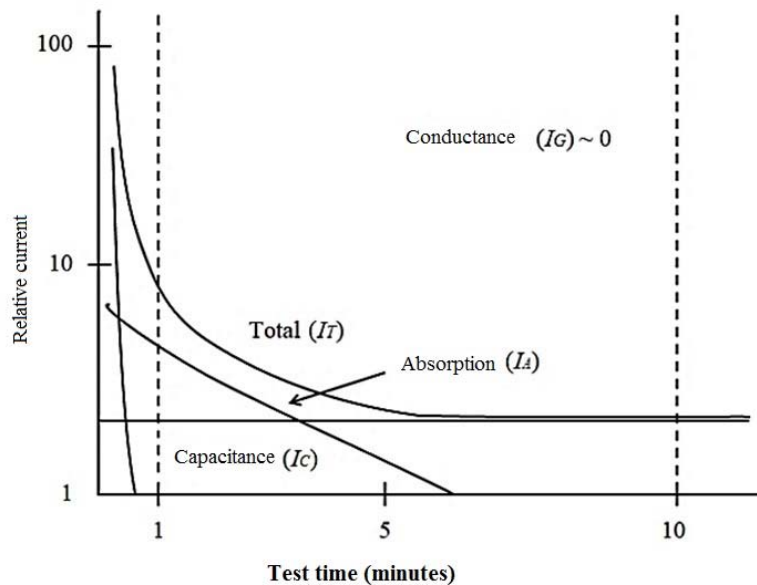
The Figure 4 shows the equivalent circuit currents behavior of the insulation system. The leakage current I_L is constant over time and normally flows over the insulation surface. The capacitive current I_C has a high magnitude for a short period, as it decays exponentially with time and applied voltage and depends on the insulation geometry. The I_G current is constant in the time and flows from the surface in contact with the core to the energized conductor and is directly related to the insulation system type. The I_A current is the result of the molecular polarization process and electrons displacement.

Figure 4: Current behavior of the insulation system equivalent circuit

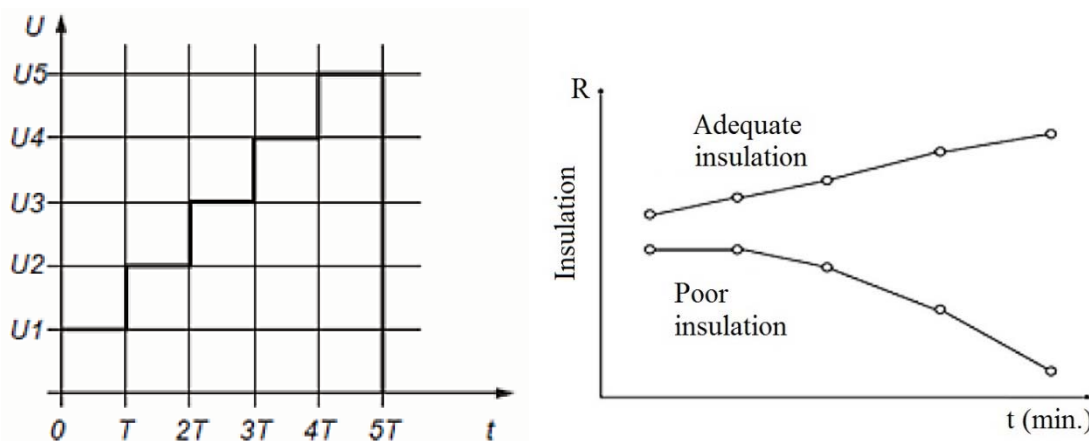
The step voltage test is applicable to electrical machines with a rated voltage greater or equal to 2300V. This test can be performed for evaluations at the factory, as well as for machines in the field. The voltage application to perform this test can be done in steps with recommended times of 1 to 3 minutes for each step. The typical increment is 1 kV per minute. The test is plotted on the XY axes (current versus applied voltage), resulting in a progressive and continuous current response. The Figure 7 shows the example of voltage steps and possible results for evaluations.

Figure 7: Typical voltage step and insulation behavior under voltage step test. (Source: BALAN H; 2010)

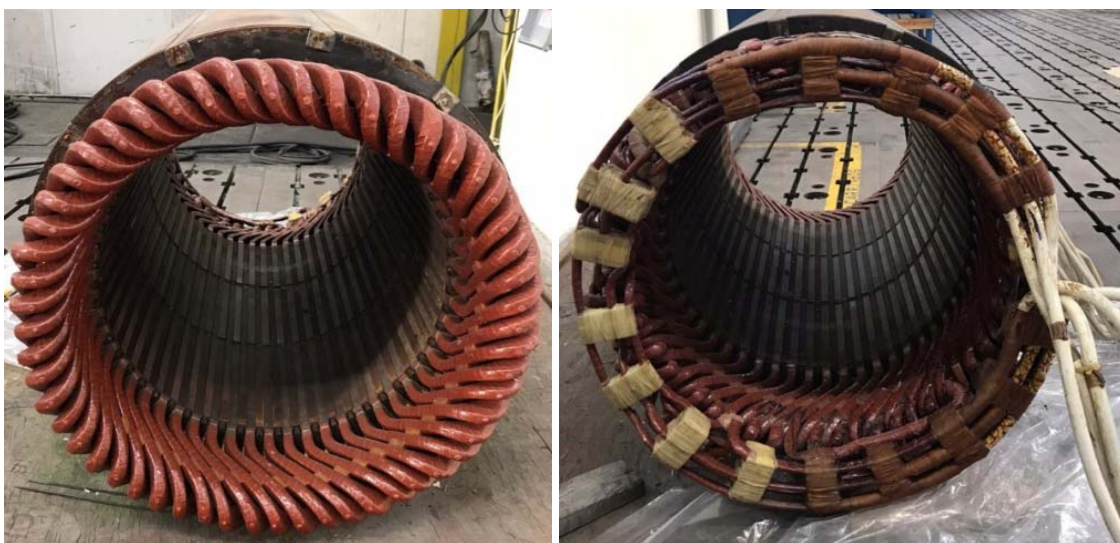
In order to demonstrate the relation between surface contamination and the damaging effects to the dielectrics used in the stator windings of high-voltage rotating electrical machines, a prototype was manufactured containing all the necessary characteristics to support a nominal voltage of 4.16kV. So that the sample's behavior could be faithful to the high voltage stator, all the necessary materials were used, such as: conductors individual insulation, main insulation with mica, surface finish layer. To finish the process, the stator was subjected to the VPI impregnation process.

For process viability reasons, the tape against corona effect was not used. This fact has no impact on the study, since the conclusions are relative, in other words, the results are presented by comparing the ideal sample with the sample submitted to the contaminant. The Figure 11 shows the sample in its original form.

Figure 11: Sample of high voltage stator (Source: WEG)

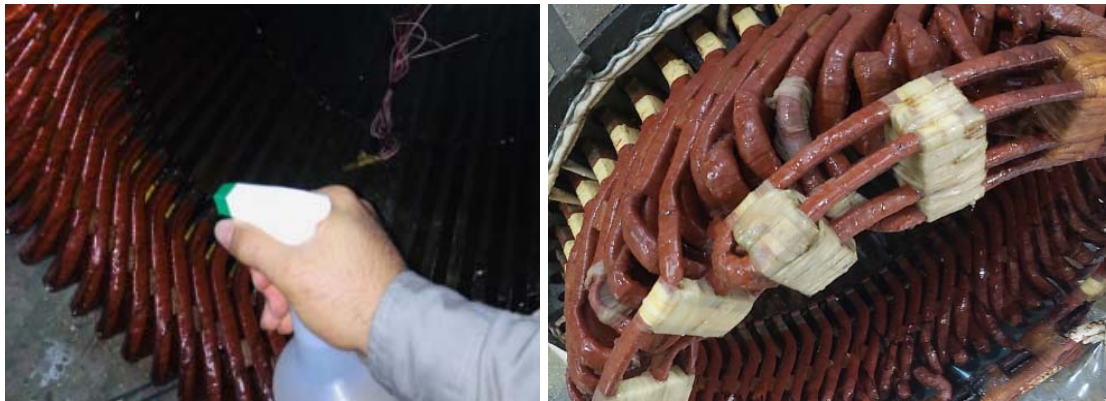
In order to simulate the dielectric behavior of the electrical machines' windings used in saline environments (oil platforms), around 35g of salt were used for each liter of water, a relation found approximately in seawater. The Figure 12 presents the sample being sprayed with the contaminant, on both sides of the coil heads.

Figure 12: Sample of high voltage stator - Contaminated (Source: WEG)

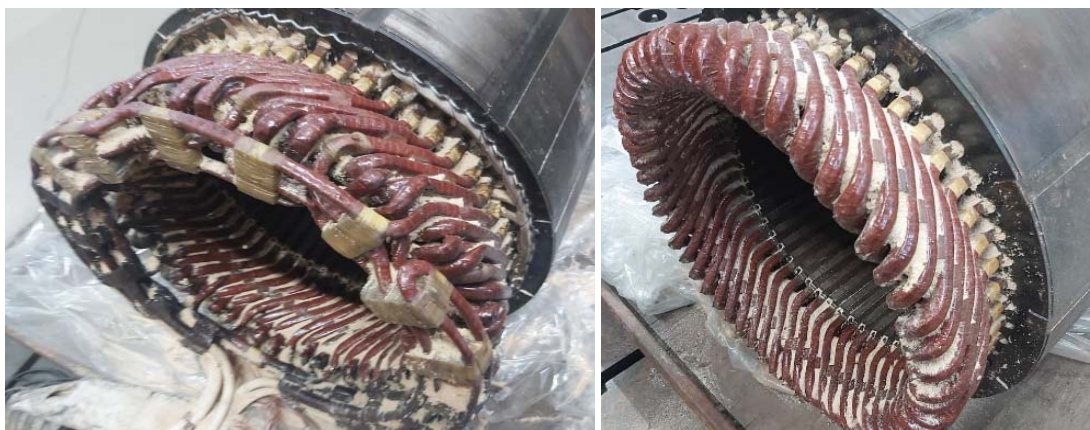
Electric machines operate in the most diverse applications and therefore, they are also subject to the most diverse contaminants suspended in the air. This soot that contaminate the windings during the operation was represented by the application of a fine and moist sawdust on the sample, as shown in Figure 13.

Figure 13: Sample contaminated with fine moist sawdust (Source: WEG)
